The Ohio Valley Coal Company
ARP R-360-70
Environmental Specialist Review
R. Scott Stiteler
9-21-2010
Revised 11-19-10

SUBSIDENCE CONTROL PLAN

Mitigation & Repair of Damage from Mining Beneath Belmont RCAG

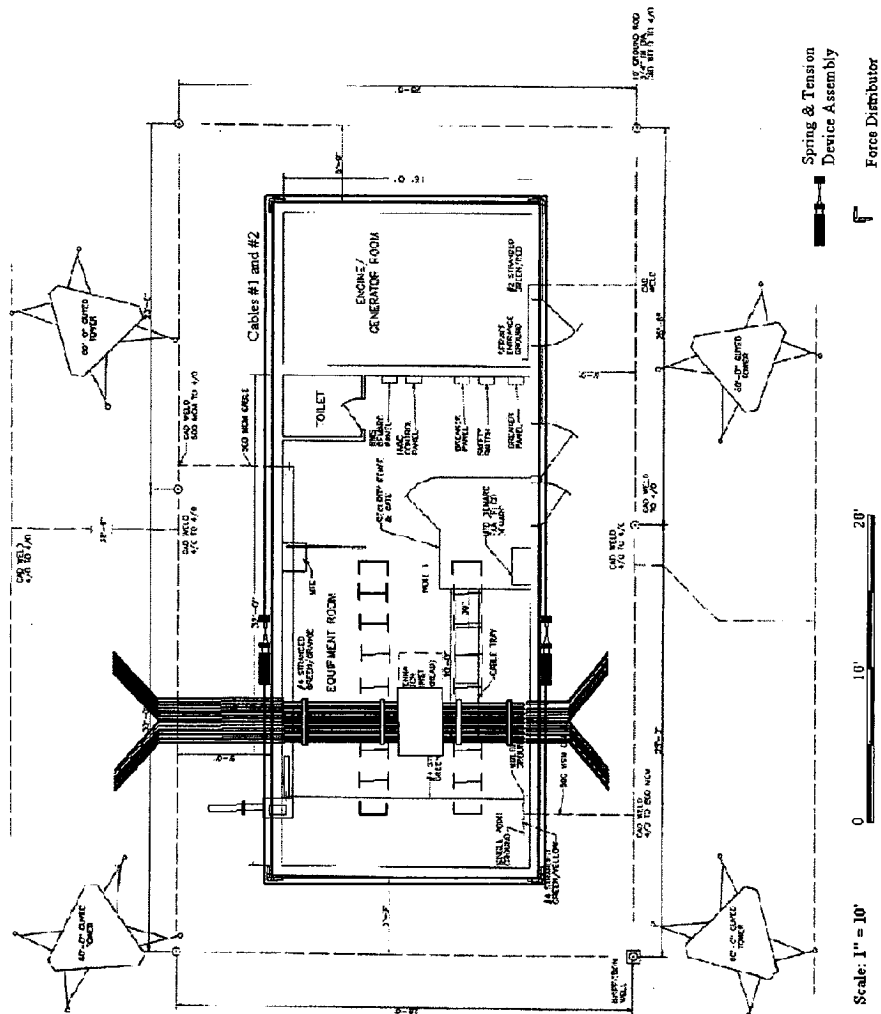
Fig. 5 Layout of the Control Building and Recommended Mitigation Measures

- The *equipment building* is a rectangular, one-story and wood frame structure (Figs. 5 and 6). Based on the provided design materials, the equipment building is 44 ft wide and 18 ft deep. It is divided into an equipment room (32 ft wide) and a smaller engine/generator room (10 ft wide). It has a 12-inch thick concrete slab floor. There is no basement or crawl space under the structure according to plans provided by the FAA and statements by FAA representatives at the site.
- The *four guyed steel lattice towers*, are numbered as #1, #2, #3 and #4 according to the order to be mined under, and are laid in a square pattern as shown in Fig. 3.

- Cracks would be induced by the dynamic tensile strain on the concrete foundation and slab floor pavement of the control building. The dynamic curvature could also cause some minor cracks to the wood frame structure. The peak dynamic slope might affect the functionality of some of the precision and equipment requiring perfect levelness (if any).

In the report, the super-structure of the control building was mistakenly recognized as a simple wood-frame structure. However, it was later discovered that the walls of the superstructure are built with concrete blocks and covered with siding. Due to the heavier weight of the wall structure than wood-frame structure, it is recommended to wrap the walls with one steel cable at a level about two feet below the gutter line. In order for the tension cable method to be more effective, the siding at the building corners at the cable level should be removed. Wood bracing should be inserted between the tension cable and the wall corners. The cable should be tensioned to 2.5 tons (5,000 lbs) during its service life. The cable can be removed and siding reattached after the longwall face has past the control building a distance of 600 ft.

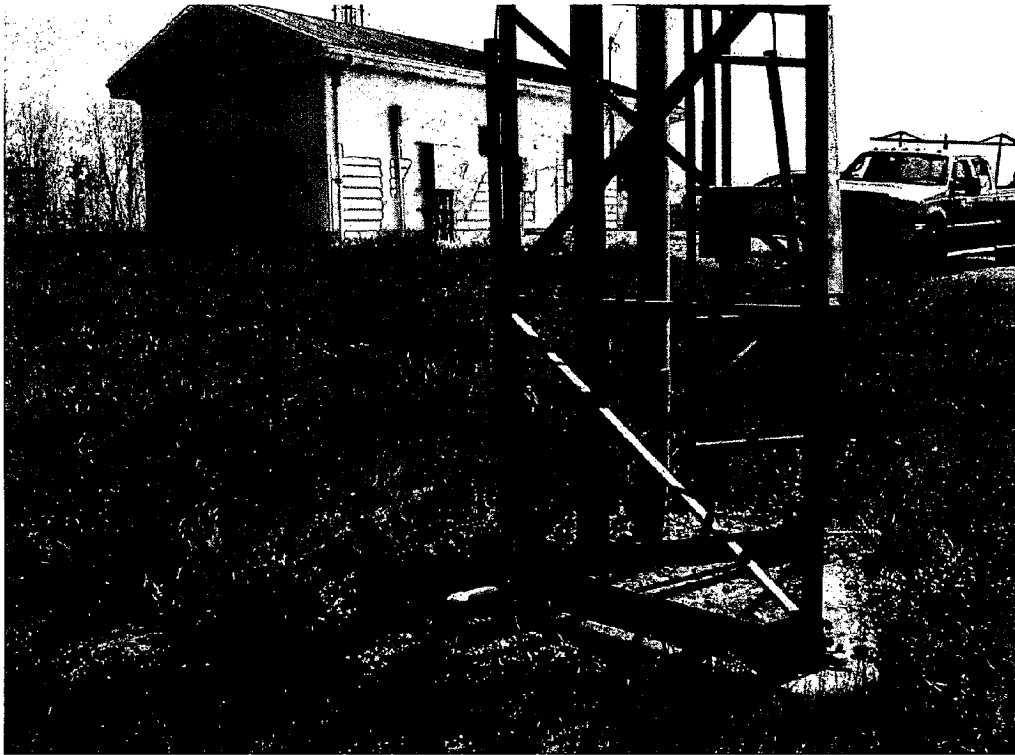
Fig. 12 Above-Ground Portions of the Cable Conduits
at the Tower and Control Building

- There are eight *buried cable conduits* connected between the equipment building and the four towers. The locations of the cables inside and leaving the control building at its front and rear walls are shown in Fig. 5 while the buried cable conduits are shown in Fig. 3 as the dashed lines. The buried lengths range from 58 to 65 ft. Figure 12 shows that two cable conduits are led to each of the towers. The cable conduits are buried 2.5 ft below the top surface of the concrete tower base or between 2.0 and 2.5 ft below ground surface. The conduits are affixed to the equipment building and the tower with braces and screws as shown in the photos in Fig. 13.

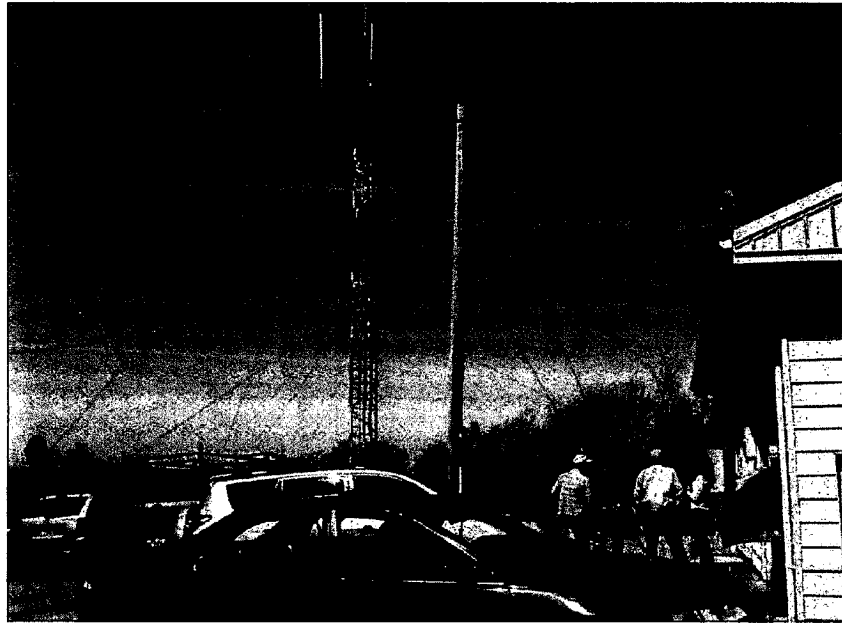
Fig. 14 Power Terminal Pole and the Power Line and Signal Line Attached to the Pole

In addition to the main structures, the other structures within the property include, a water well (depth unknown) located a short distance behind the equipment building, a septic tank, a leaching field, a power terminal pole and a small asphalt paved parking lot as shown in Fig. 3. The power lines attached to the pole (Fig. 14) show sufficient sag for the anticipated subsidence event.

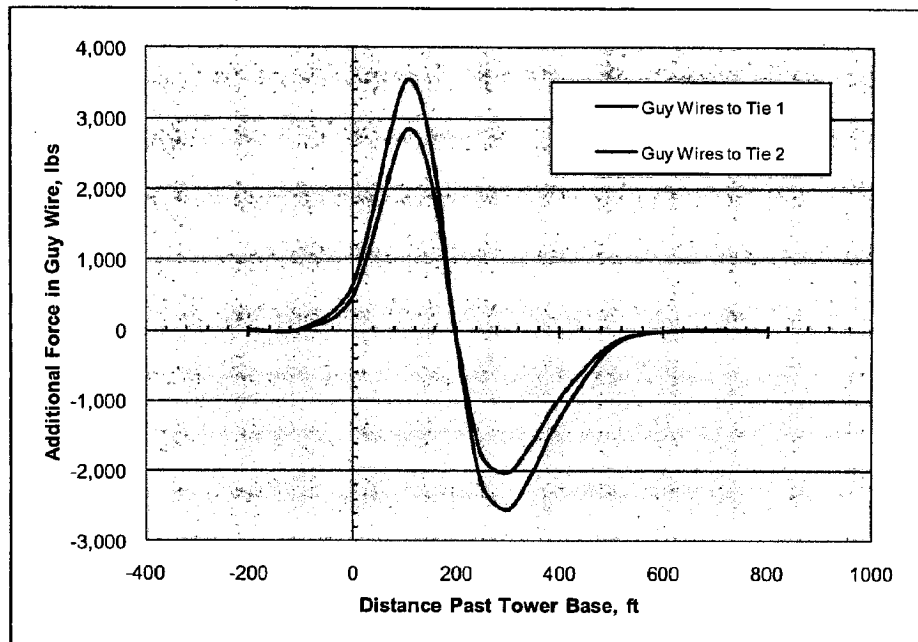
Fig. 31 Force Changes in the Guy Wires of Tower No. 3

Figure 31 shows that the force in the guy wires tied to the middle point of the tower is larger than that tied to the top. It also shows that the guy wires are all in tension before the longwall face has past the tower base a distance of 150 ft (the first phase of the subsidence phase). During the first phase, the peak tensions are 3,500 and 2,800 lbs on the wires tied to ties 1 and 2, respectively, when the face is about 100 ft past the tower base. The original tension in the guy wires were not specified in the provided tower design documents. However, a FAA representative at the time of our site visit mentioned that the tension should be between 150 and 200 lbs (seemingly a reasonable value judged by the way that the guy wires are connected to the tower as shown in Fig. 11). A 200-lbs pre-mining tension is listed in Table 1. However, a previous project on guyed tower showed that the pre-mining guy wire tensions in the magnitude of 1,000 to 2,000 lbs are commonly used. Compared to these cited original tension values, the estimated subsidence-induced peak tensions in the guy wires are high but much less than the ultimate break strengths of the guy wires (10,600 lbs for 3/8" wire rope). The guy wires at such tensions should be safe but it should not be left unattended.

- The dynamic subsidence process could also induce high additional tensions on the guy wires in the first phase of the dynamic subsidence process. The additional tensions may be able to cause structural problems to the towers. In the second phase of the dynamic subsidence process, the slack guy wires would lose effective restraints to the tower structure and would allow the tower to vibrate in strong winds.
- The buried cable conduits may be stretched excessively.

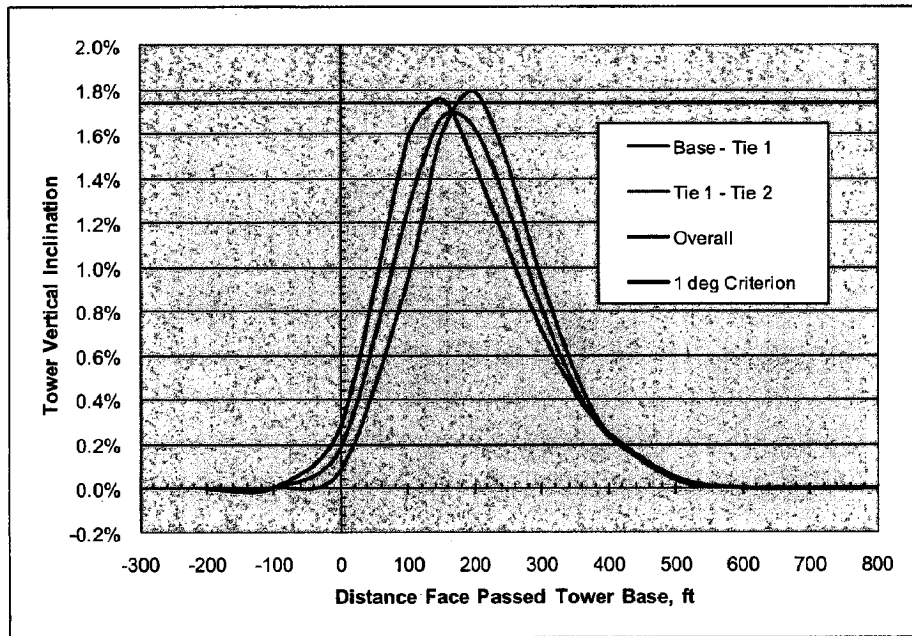
Fig. 33 Tower Inclination during Dynamic Subsidence Process

on the determined coordinates and elevations of the tower base and the ties (Table 3), the inclinations of the tower structures away from the vertical direction at each time stage are determined for each section and the entire height of the tower. The results including inclinations along x and y directions as well as the principal one are listed in Table 5. The principal inclinations at different time stages are shown in Fig. 33. It is found that the inclination of the tower structure would be most severe when the longwall face is about 200 ft past the tower base. The maximum inclination, 1.796% (1.12°) exceeds the 1° criterion for dish antenna but less than the existing inclinations observed on the antennas.

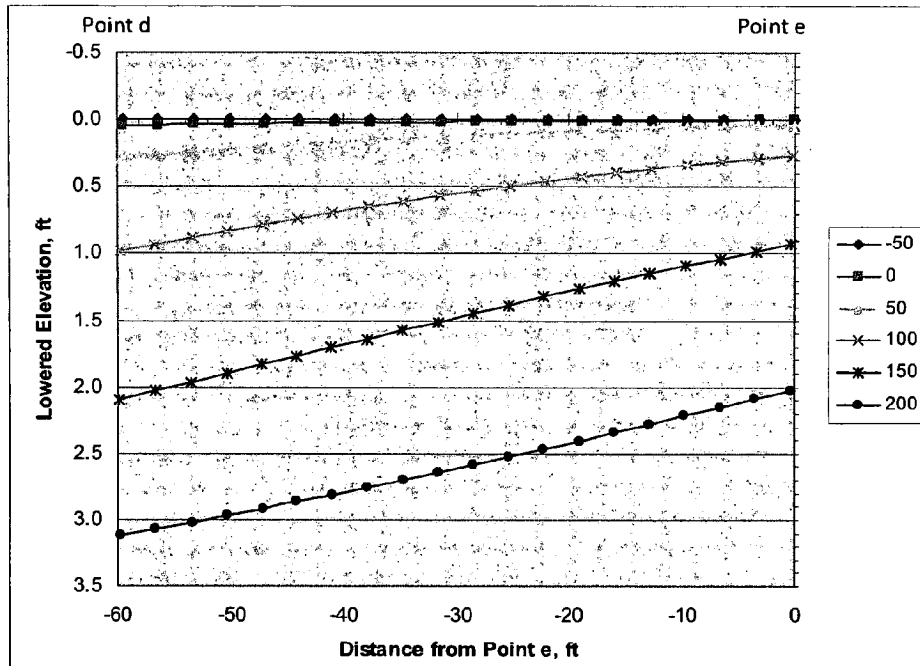
Fig. 34 Predicted Conditions of the Cable Conduits for Tower No. 4

Based on the predicted profiles, the total lengths of the buried conduits at different time stages can be determined. The elongation of the conduits and average cable strain are calculated and plotted in Fig. 35. It shows that the buried conduits would be elongated up to 0.16 ft (1.9 inches) when the longwall face has past the base of tower No. 4 a distance of 100 ft. At the same time, the average tensile strain on the conduits and cables would be as high as 2.7×10^{-3} ft/ft. Such tensile strain could induce large forces on the connecting ties on the control building and on the tower without mitigation.
